U.S.-Canada Power System Outage Task Force

Final Report on the August 14, 2003 Blackout in the United States and Canada: Causes and Recommendations

April 2004

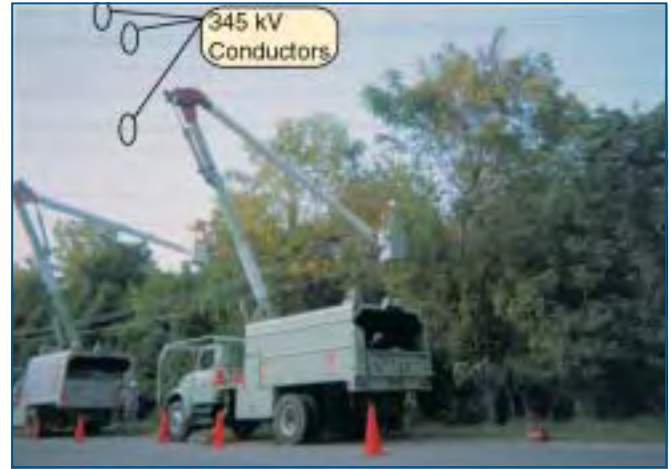
This August 14 photo shows the tree that caused the loss of the Hanna-Juniper line (tallest tree in photo). Other 345-kV conductors and shield wires can be seen in the background. Photo by Nelson Tree.
